# Energy Efficiency Infrared Report

Your Street  
Anytown, Massachusetts 00000

Date:00/00/00  
Time of Day:00:00 AM - 00:00 AM  
Exterior Temperature:32 degrees F.  
Interior Temperature:69 degrees F.  
Delta T:37 degrees F.

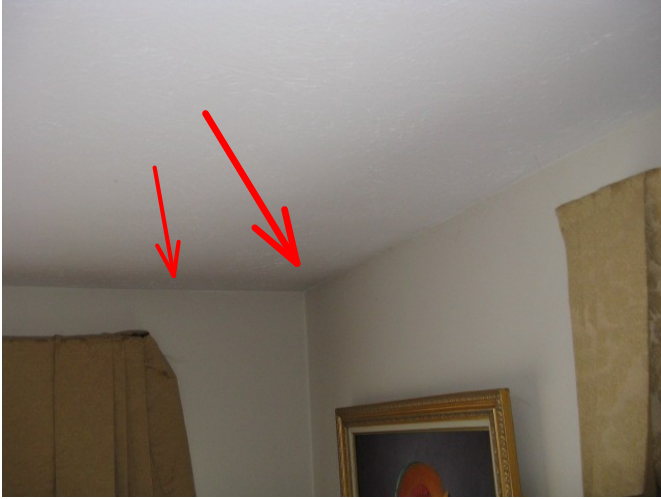
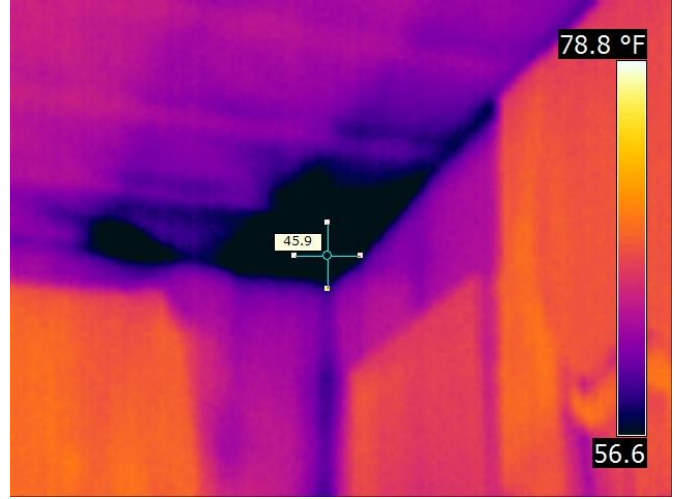
Location Floor: First Floor  
 Location Room: Dining Room  
 Location Direction: Facing the rear of your house

Throughout this Infrared Report you are going to be viewing dark blue and purple areas which are insulation voids where cold air is infiltrating the conditioned areas of your home. It is quite evident (here) that insulation is not properly installed at this concealed structural rim joist cavity. See "Closing Comments" for recommended upgrades.

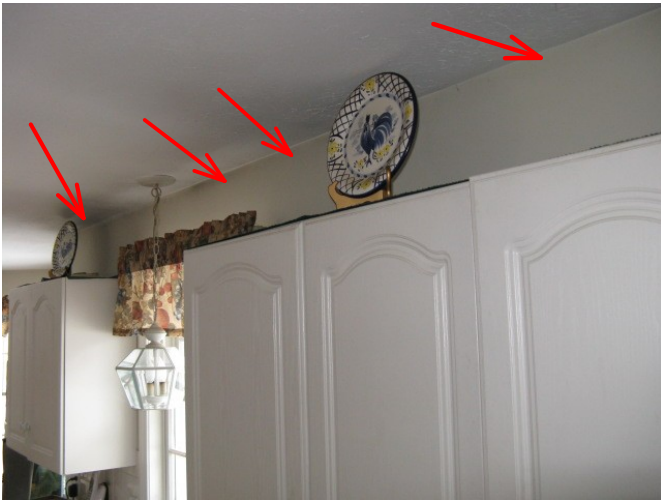
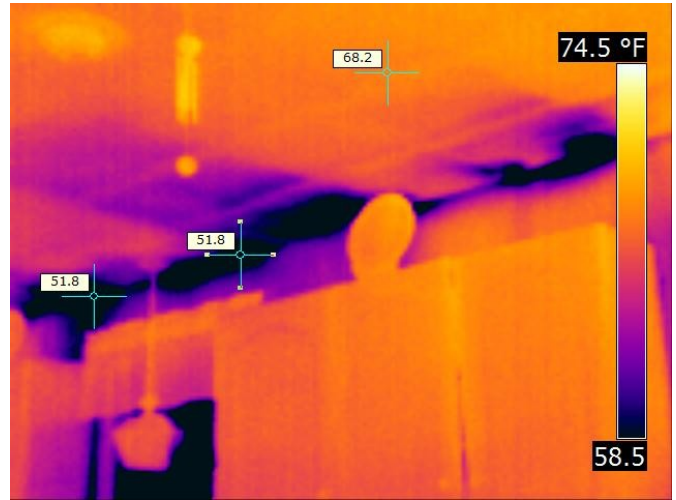
Location Floor: First Floor  
 Location Room: Kitchen  
 Location Direction: Facing the rear of your house

The concealed rim joist cavity (above your kitchen sink) is not properly insulated. See "Closing Comments" for recommended upgrades.

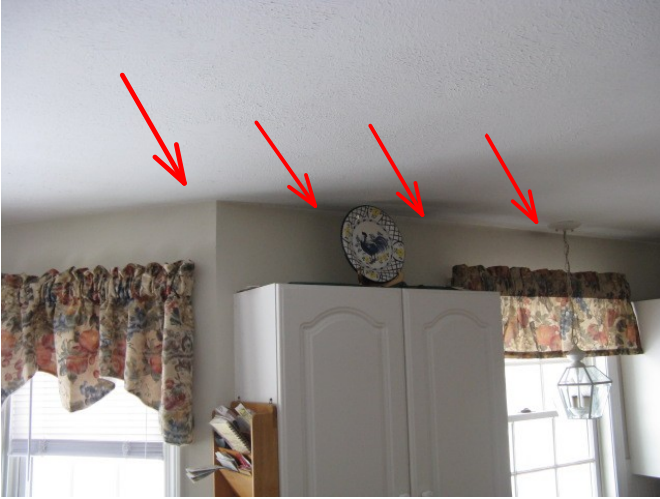
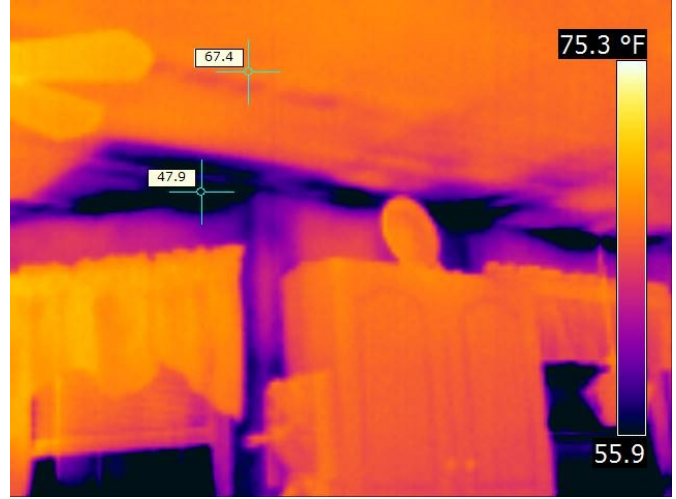
Location Floor: First Floor  
 Location Room: Kitchen (Left side)  
 Location Direction: Facing the rear of your house

**Observations:**  
 This is another view of the same area that requires an insulation upgrade for thermal efficiency in this area.

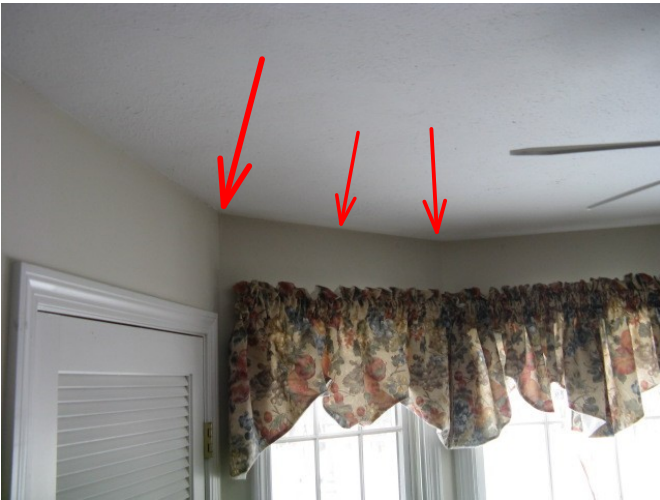
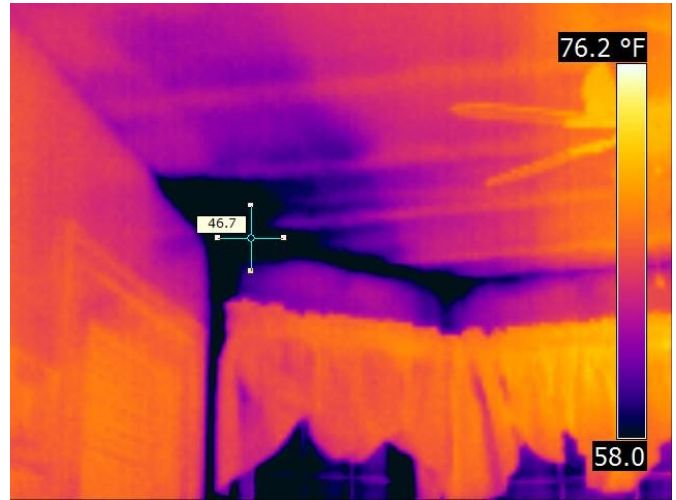
Location Floor: First Floor  
 Location Room: Kitchen (at eating table)  
 Location Direction: Facing the left rear of your house

**Observations:**  
 This outer ceiling is inefficient due to improper installation of insulation in the concealed rim joist cavity. See "Closing Comments" for recommended upgrades.

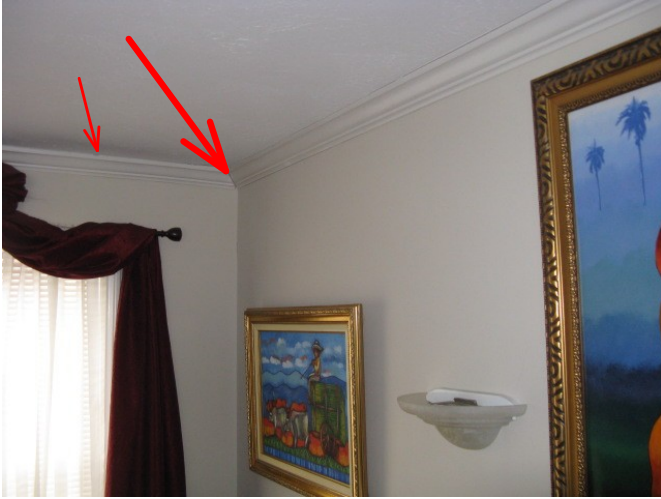
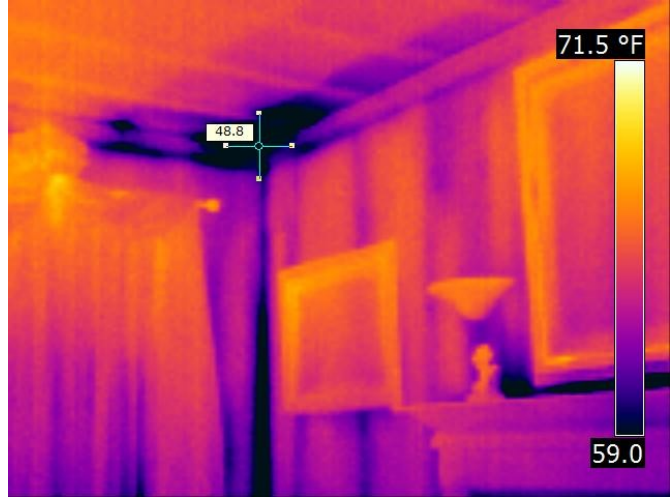
Location Floor: First Floor  
 Location Room: Family Room  
 Location Direction: Facing the front of your house

**Observations:**  
 The upper corner portion of this particular ceiling cavity needs an insulation upgrade. See "Closing Comments" for recommended upgrades.

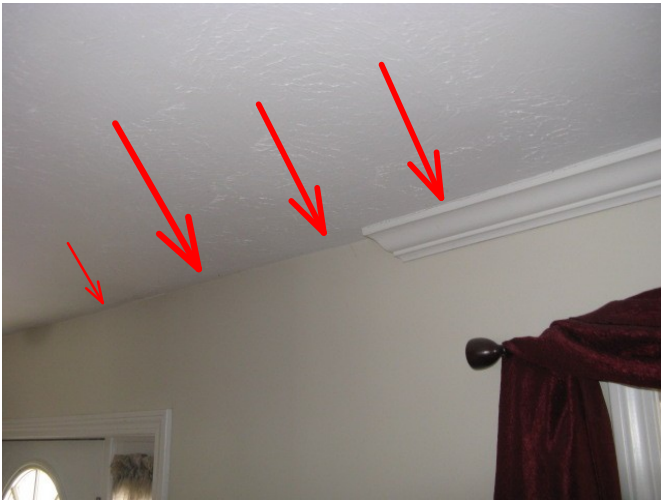
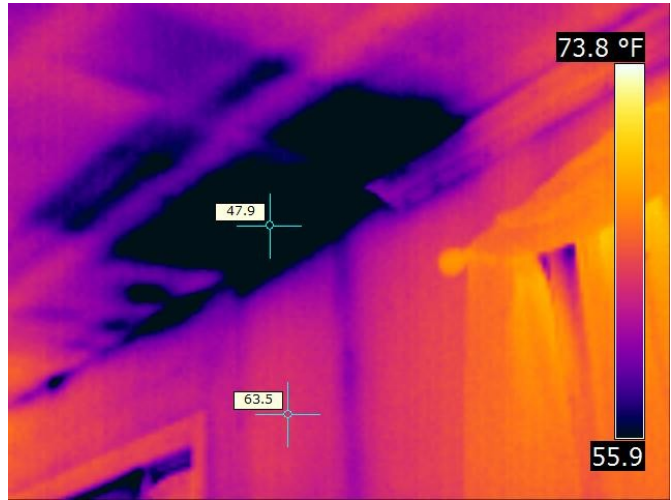
Location Floor: First Floor  
 Location Room: Above Front Entry Door  
 Location Direction: Facing the front of your house

**Observations:**  
 You can clearly see (here) that excessive cold air is infiltrating your main entry area. See "Closing Comments" for recommended upgrades.

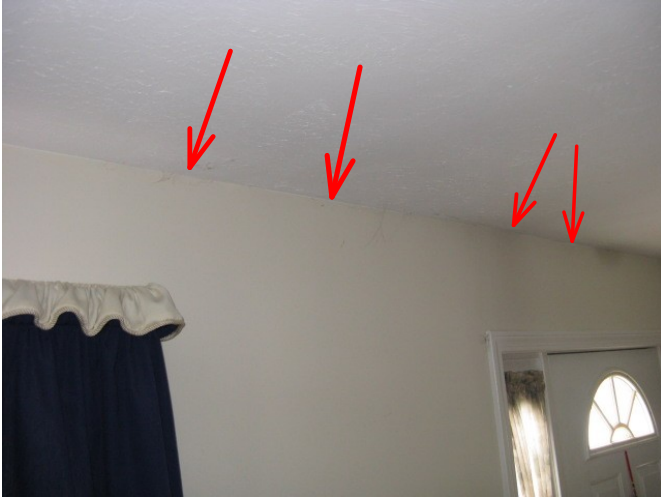
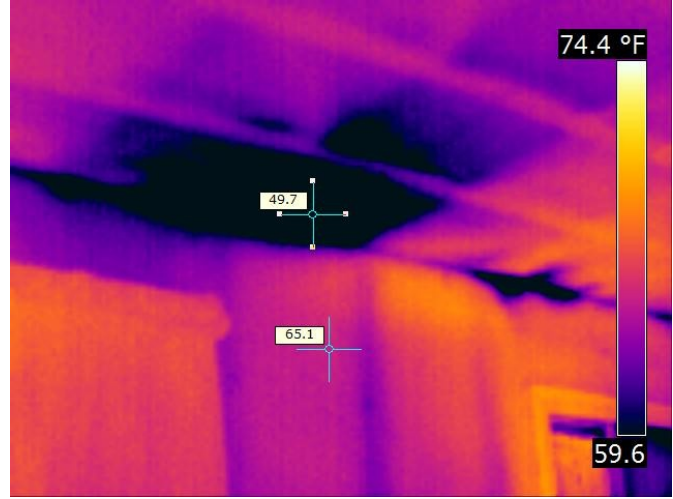
Location Floor: First Floor  
 Location Room: Living Room & Main Entry  
 Location Direction: Facing the front of your house

**Observations:**  
 This is another rim joist cavity that needs an insulation upgrade.

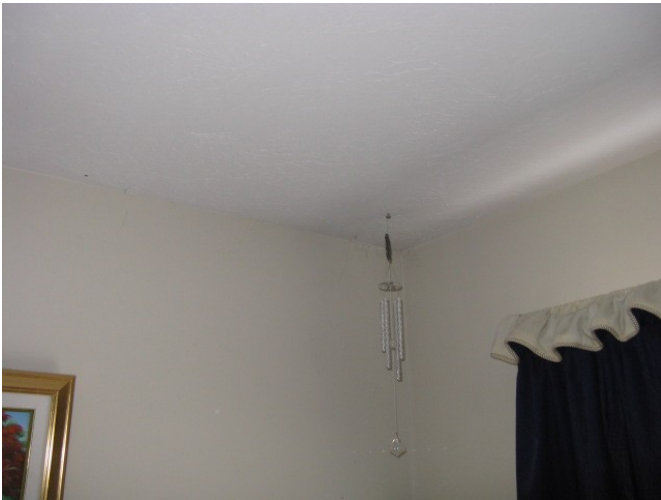
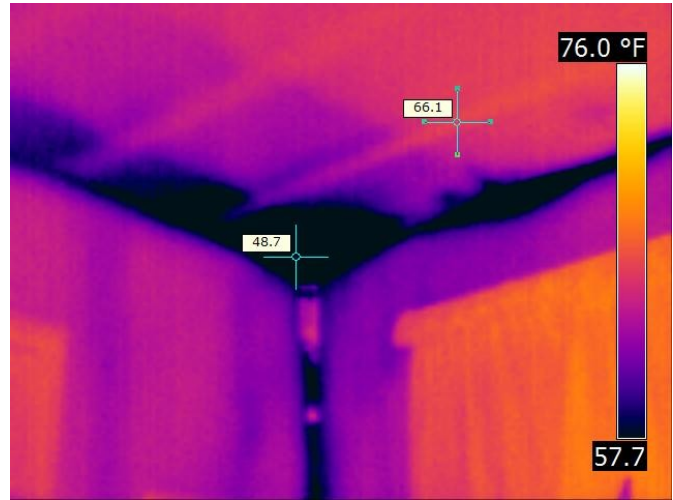
Location Floor: First Floor  
 Location Room: Living Room  
 Location Direction: Facing the left front corner of your house

**Observations:**  
 This upper concealed ceiling cavity is allowing cold air into your living room. See "Closing Comments" for recommended upgrades.

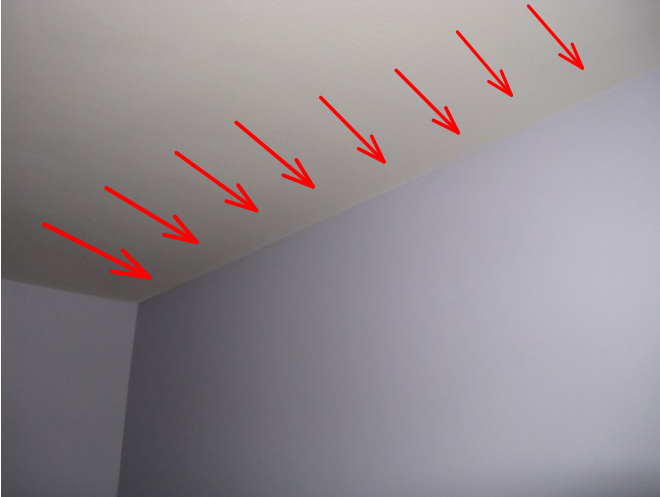
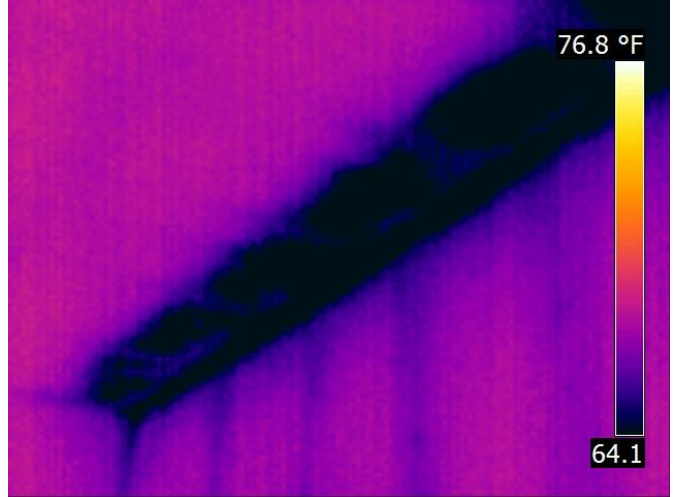
Location Floor: Second Floor  
 Location Room: Bedroom  
 Location Direction: Facing the front of your house

**Observations:**  
 This is another ceiling cavity that is allowing cold air to infiltrate your bedroom through empty ceiling joist cavities. See "Closing Comments" for recommended upgrades.

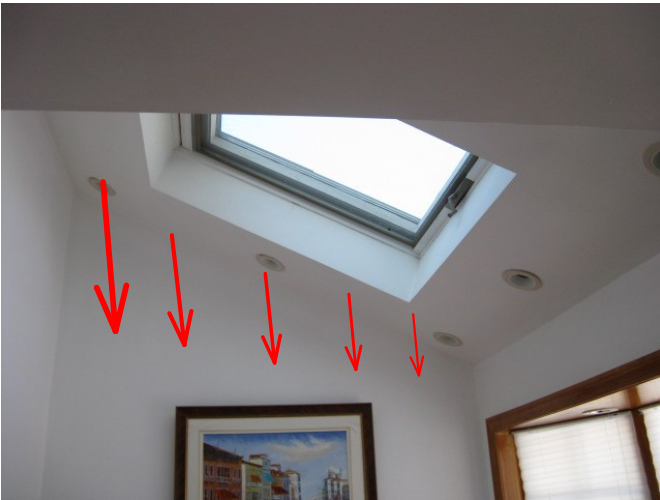
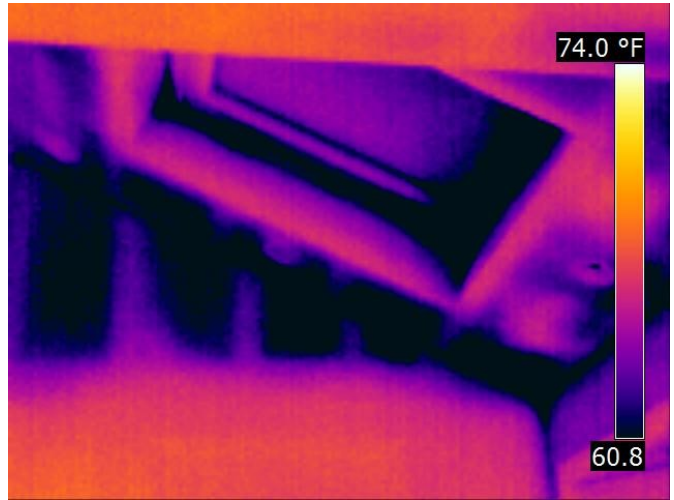
Location Floor: Second Floor  
 Location Room: Bathroom  
 Location Direction: Facing the rear of your house

**Observations:**  
 You can clearly see that the upper attic wall cavities (inside your attic) of this bathroom are not insulated at all. See "Closing Comments" for recommended upgrades.
